**Flood Control Project Maintenance  
Levee Inspections**  
**LMA District Cover Sheet**  
**Spring 2016 Levee Inspection Results**

**Reclamation District No. 2031 Elliot**

**Levee Inspection Report By Mile - Spring 2016**

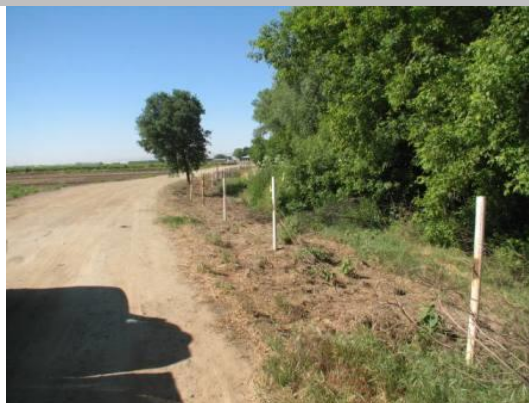
Photo 1 of 3 : SP\_2016\_RD2031\_307\_7\_20160229\_00009.jpg

05/10/2011 Fence on waterside prevents access to waterside slope.

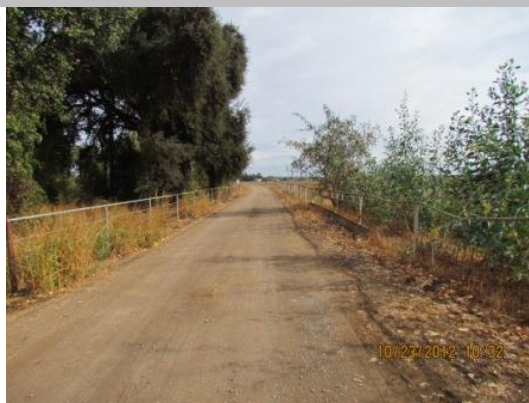
Photo 2 of 3 : SP\_2016\_RD2031\_307\_7\_20160229\_00010.jpg

View of fence obstructing access to waterside slope. Facing upstream.

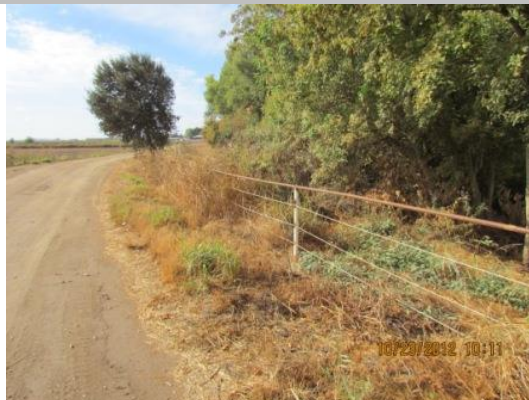
Photo 3 of 3 : SP\_2016\_RD2031\_307\_7\_20160229\_00011.jpg

LM Start	<b>0.34</b>	Rating **	M	Issue No.	<b>7 (cont)</b>
LM End	<b>0.52</b>	Issue Type +	En	Location *	WS

View of fence on waterside slope facing downstream.

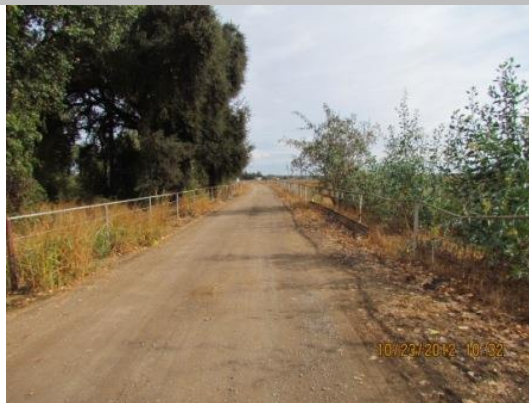
Photo 1 of 2 : SP\_2016\_RD2031\_307\_14\_20160229\_00014.jpg

View of fence on landside levee shoulder obstructing access to landside slope. Facing upstream.

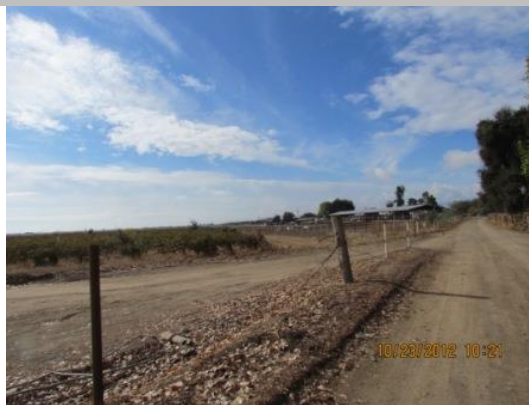
Photo 2 of 2 : SP\_2016\_RD2031\_307\_14\_20160229\_00015.jpg

View of fence on landside levee shoulder facing downstream.

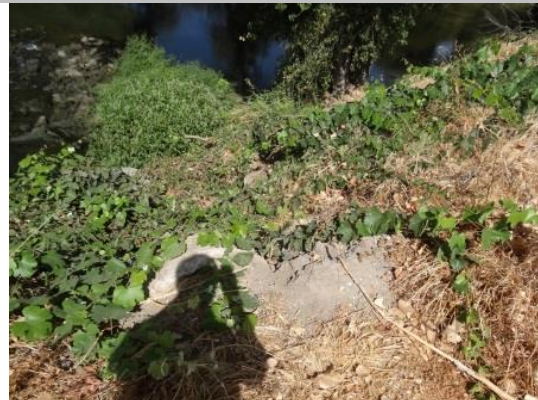
Photo 2 of 3 : SP\_2016\_RD2031\_307\_1\_20160229\_00002.jpg

View of the current condition of the bank slope just above the irrigation outlet.

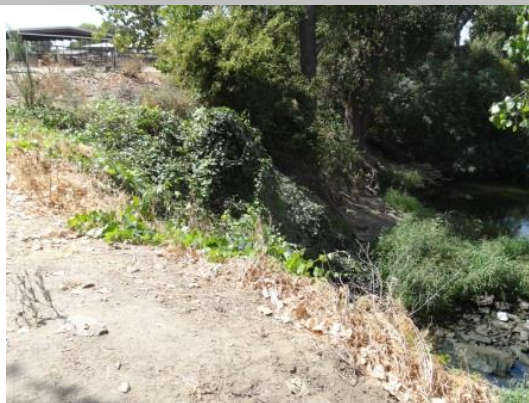
Photo 3 of 3 : SP\_2016\_RD2031\_307\_1\_20160229\_00003.jpg

Comment Code						
Inspector Comment						
08/28/2015: No significant change observed.						
07/31/2014: No significant change observed.						
09/10/2013: No significant change observed.						
07/18/2012: No significant change observed.						
08/18/2011: No significant change observed on site. Debris that blocks the irrigation outlet is visible.						
10/19/2010: No significant change observed on site. Sloughing of the bank is occurring adjacent to an irrigation outlet structure. There is moderate to heavy vegetation along the bank that is well established. Broken chunks and slabs of concrete are used as rip rap and line the outside of the irrigation outlet structure. However, much of the rip rap along the slope is sloughing and could possibly lead to future slope instability.						
08/05/2010: Recommended as a local maintenance issue, per CLRO.						
08/20/2009: No major change observed since last visit; 1 inch fissure cracks developing on the slope; rip rap is showing signs of sloughing; recommend as local maintenance issue; site was previously rated "U".

View of the loose material at the bank top.

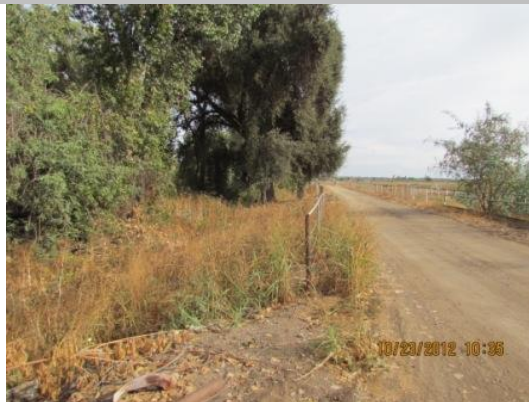
Photo 1 of 2 : SP\_2016\_RD2031\_307\_2\_20160229\_00004.jpg

LM Start	0.48	Rating **	M	Issue No.	2
LM End	0.51	Issue Type +	Ma	Location *	WS
Category	Earthen Levee			GPS Latitude/Longitude	
				Start	End
Item	Vegetation			37.704385 °	37.704050 °
				-121.159217 °	-121.159578 °
DWR ID	DWR_RD2031_01_s_2012_2				
Comment Code					
V2 : Remove the wild growth other than native grasses from the levee slopes.					
Inspector Comment					
Remove vegetation 20 feet away from the levee crown.

View of vegetation on waterside slope. Facing upstream.

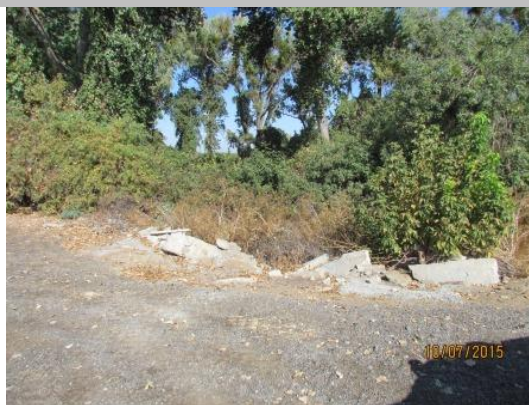
Photo 1 of 1 : SP\_2016\_RD2031\_307\_48\_20160229\_00022.jpg

LM Start	0.51	Rating **	M	Issue No.	48
LM End	0.51	Issue Type +	En	Location *	WS
Category	Earthen Levee			GPS Latitude/Longitude	
				Start	End
Item	Encroachments			37.704041 °	37.704041 °
				-121.159629 °	-121.159629 °
DWR ID	DWR_RD2031_01_f_2015_48				
Comment Code					
MA : Material					
Inspector Comment					
Concrete dumped on the waterside slope.

View of the concrete placed on the waterside levee slope.

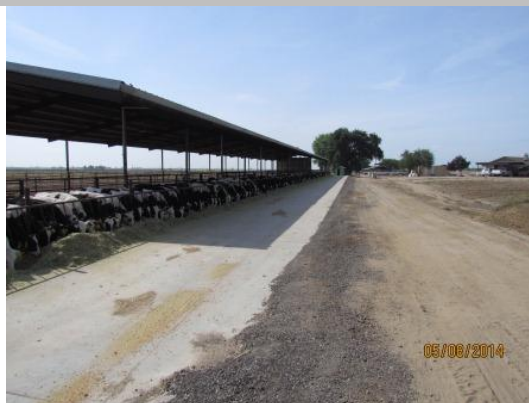
Photo 1 of 1 : SP\_2016\_RD2031\_307\_969\_20160229\_00039.jpg

LM Start	0.54	Rating **	U	Issue No.	969
LM End	0.65	Issue Type +	En	Location *	LS
Category	Earthen Levee			GPS Latitude/Longitude	
				Start	End
Item	Encroachments			37.703626 °	37.702648 °
				-121.159714 °	-121.160700 °
DWR ID	DWR_RD2031_01_s_2012_969				
Comment Code					
BU : Building					
Inspector Comment					
Corrals and house on levee slope and crown. Demolition in progress.

View of the new coral at the landside levee slope and toe.

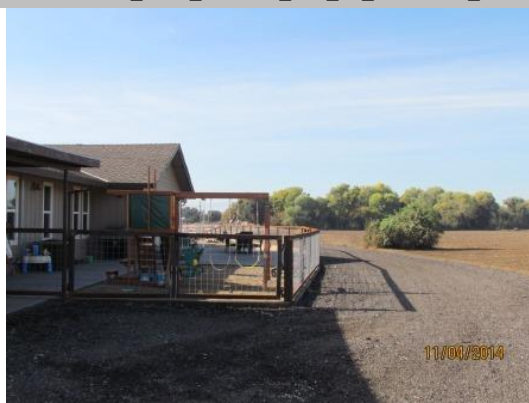
Photo 1 of 1 : SP\_2016\_RD2031\_307\_58\_20160229\_00032.jpg

View of the unpermitted fence on the landside levee hinge.

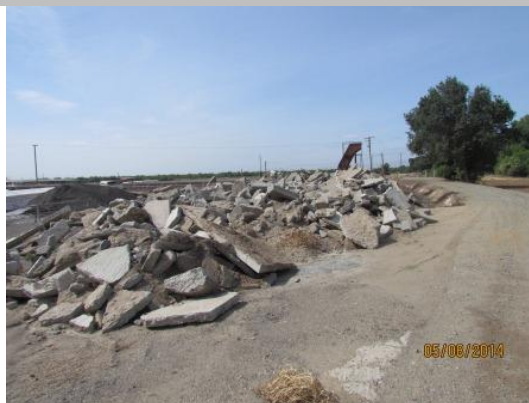
Photo 1 of 1 : SP\_2016\_RD2031\_307\_127\_20160229\_00036.jpg

View of the concrete debris stockpiled at the landside levee toe.

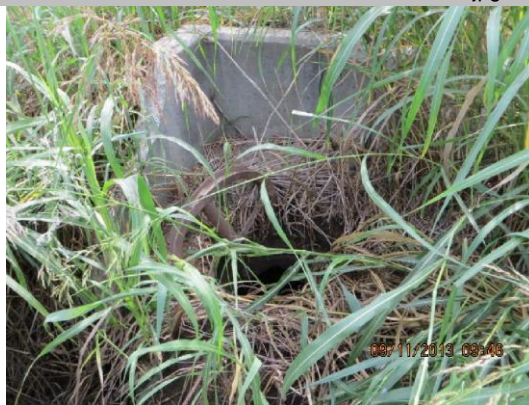
Photo 2 of 2 : UCIP\_SP\_2016\_20046\_33945.jpg

LM Start	0.72	Rating **	M	Issue No.	984	
LM End	0.72	Issue Type +	En	Location *	LS	
Category	Supplemental			GPS Latitude/Longitude		
				Start		End
Item	DWR UCIP Field Study			37.701912 °		37.701912 °
				-121.161642 °		-121.161642 °
DWR ID						
Comment Code						
Inspector Comment						
FS_ID:20046						
DS_ID:20440						
EP_NO: N/A						
Repair Type: Non-Urgent						
Crossing Status: Found						
UCIP Comments: Alfalfa valve on the WS toe is damaged.						
FIELD_STRUCT_DESC: 30-inch corrugated metal irrigation pipe through the levee 5.0-feet below the crown. Flashboard slots in concrete headwall on the landward side. Distribution box with alfalfa valve on the waterward side. Installed by USACE, 1966. Replaced a 30-inch pipe at same location.						
FS Date: 9/11/2013

Concrete headwall and damaged alfalfa valve on WS toe.

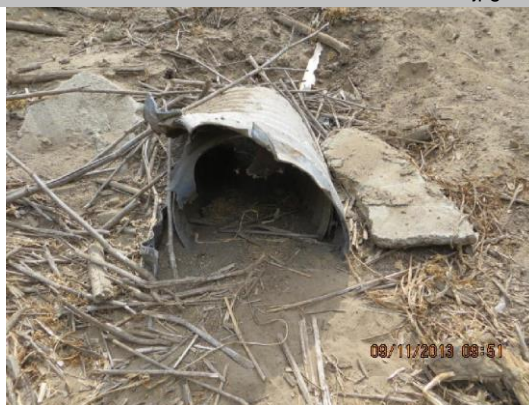
Photo 1 of 2 : UCIP\_SP\_2016\_20047\_33950.jpg

LM Start	0.75	Rating **	M	Issue No.	985
LM End	0.75	Issue Type +	En	Location *	LS
Category	Supplemental			GPS Latitude/Longitude	
				Start	End
Item	DWR UCIP Field Study			37.701552 °	37.701552 °
				-121.161883 °	-121.161883 °
DWR ID					
Comment Code					
Inspector Comment					
FS_ID:20047 DS_ID:20441 EP_NO: N/A Repair Type: Non-Urgent Crossing Status: Found UCIP Comments: This pipe appears abandoned and if so, should be done so appropriately. FIELD_STRUCT_DESC: 15-inch corrugated metal pipe through levee 4.0 feet below crown. Flashboard slots on the landward side. Installed by USACE 1966. Originally included in the 1968 O&M manual. FS Date: 9/11/2013

Damaged CMP pipe on WS slope.

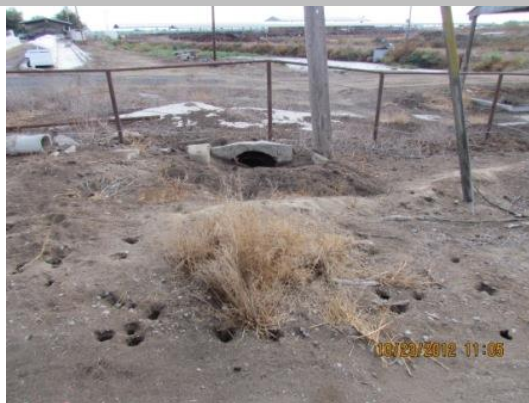
Photo 1 of 1 : SP\_2016\_RD2031\_307\_36\_20160229\_00018.jpg

View of rodent burrows on landside slope.

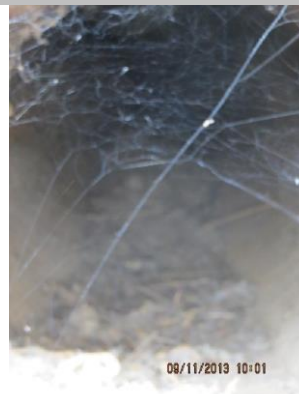
Photo 2 of 2 : UCIP\_SP\_2016\_20049\_33955.jpg

FS\_ID:20049  
DS\_ID:20443  
EP\_NO: N/A  
Repair Type: Non-Urgent  
Crossing Status: Found  
UCIP Comments: Pipe appears abandoned as WS slope is covered with soil. If abandoned, it should be done so properly.  
FIELD\_STRUCT\_DESC: 24-inch steel pipe through levee 2.0-feet below the crown. Concrete headwall on both sides of levee crown.  
FS Date: 9/11/2013

Pipe not filled with concrete.

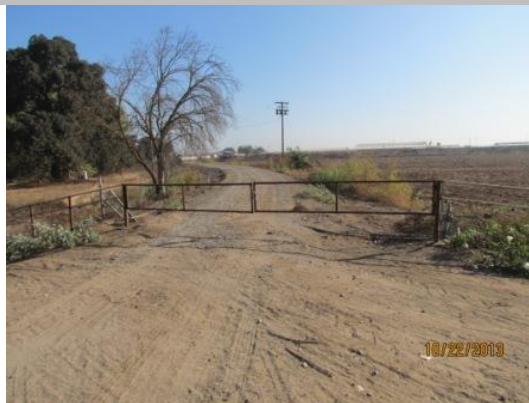
Photo 1 of 1 : SP\_2016\_RD2031\_307\_51\_20160229\_00025.jpg

View of the gate across levee crown.

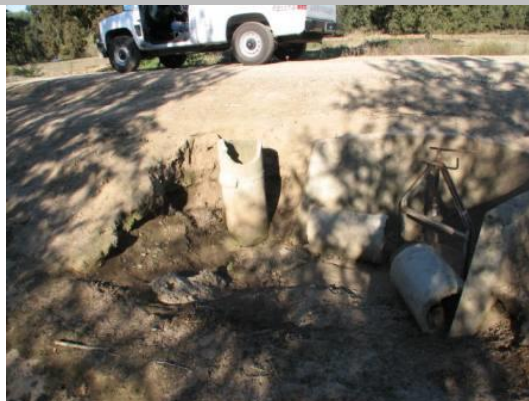
Photo 2 of 2 : SP\_2016\_RD2031\_307\_3\_20160229\_00007.jpg

10/26/2011 Active erosion into the levee prism around irrigation standpipe.

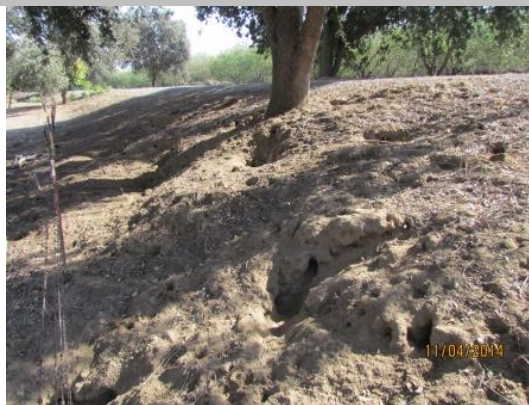
Photo 1 of 2 : SP\_2016\_RD2031\_307\_52\_20160229\_00026.jpg

View of the multiple large rodent hole in the waterside levee slope.

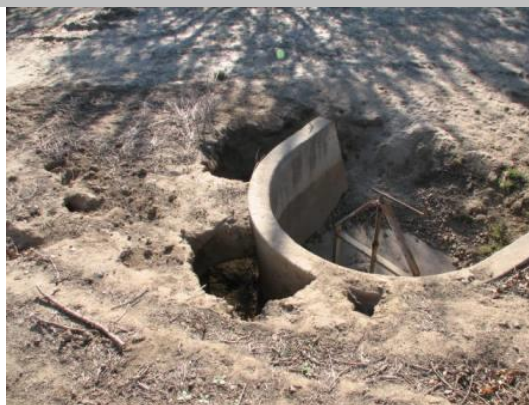
Photo 1 of 1 : SP\_2016\_RD2031\_307\_9\_20160229\_00013.jpg

10/26/2011 Active erosion into levee prism around irrigation inlet.

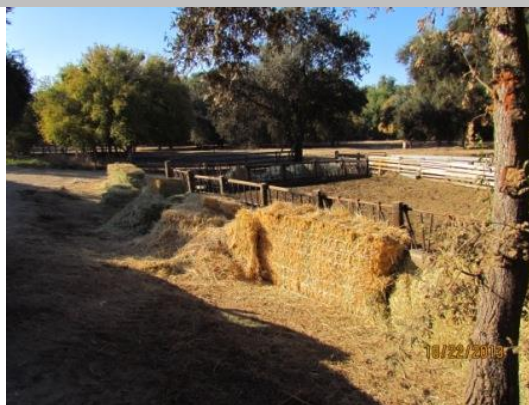
Photo 1 of 1 : SP\_2016\_RD2031\_307\_37\_20160229\_00019.jpg

View of the hay bails at the waterside levee toe.

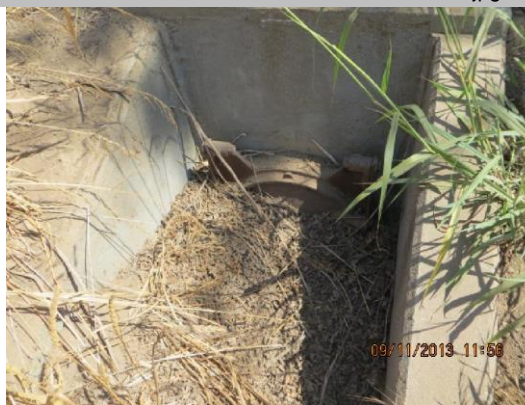
Photo 2 of 2 : UCIP\_SP\_2016\_20109\_34074.jpg

FS\_ID:20109  
DS\_ID:20448  
EP\_NO: N/A  
Repair Type: Non-Urgent  
Crossing Status: Found  
UCIP Comments: If abandoned it should be done so properly if not, the pipe should be cleared of soil blockage.  
FIELD\_STRUCT\_DESC: \*Abandoned\* 24-inch pipe through levee 6.8 feet below crown. Concrete headwalls on both ends. Flap gate on the waterward end. Installed by USACE, 1966.  
FS Date: 9/11/2013

Flapgate on WS toe.

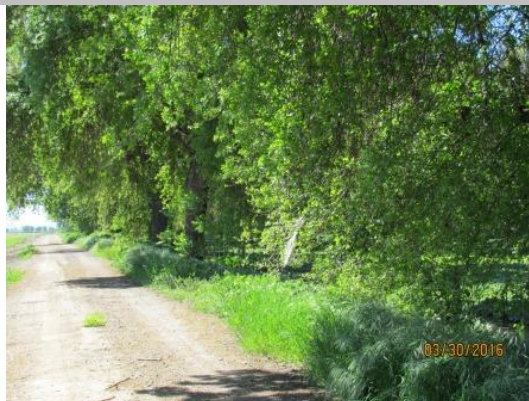
Photo 1 of 1 : SP\_2016\_RD2031\_307\_30\_20160412\_00084.jpg

View of the vegetation on the waterside levee slope.

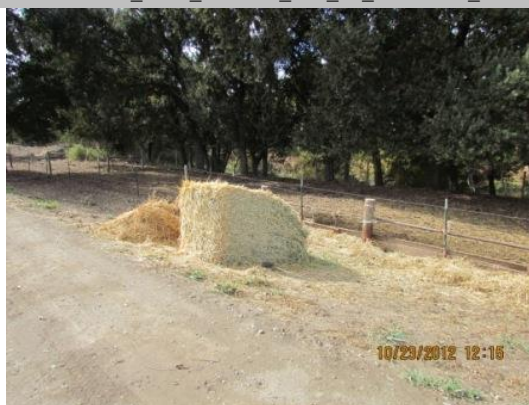
Photo 1 of 1 : SP\_2016\_RD2031\_307\_39\_20160229\_00020.jpg

View of hay bales at toe of levee on waterward side, facing downstream.  
05/02/2012

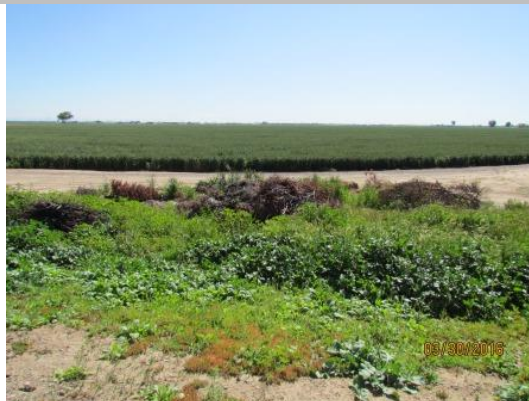
Photo 1 of 1 : SP\_2016\_RD2031\_307\_53\_20160412\_00085.jpg

View of the debris at the landside levee toe.

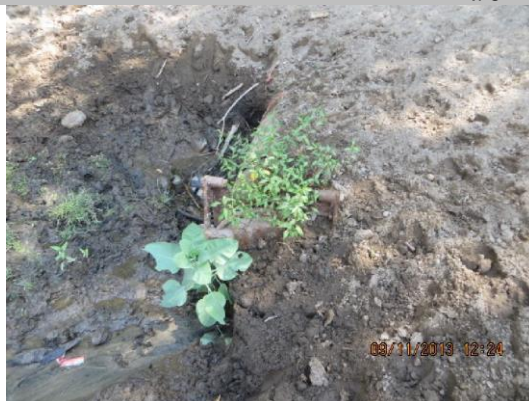
Photo 2 of 2 : UCIP\_SP\_2016\_43094\_39001.jpg

LM Start	2.45	Rating **	U	Issue No.	997
LM End	2.45	Issue Type +	En	Location *	LS
Category	Supplemental			GPS Latitude/Longitude	
				Start	End
Item	DWR UCIP Field Study			37.687949 °	37.687949 °
				-121.180305 °	-121.180305 °
DWR ID					
Comment Code					
Inspector Comment					
FS_ID:43094					
DS_ID:24669					
EP_NO: N/A					
Repair Type: Urgent					
Crossing Status: Found					
UCIP Comments: Flapgate partially blocked by soil on WS toe. Good candidate for video inspection.					
FIELD_STRUCT_DESC: 24-inch CMP stormdrain pipe through the levee at unknown depth. Flapgate on WS toe. Pipe may originate at concrete distribution box on LS toe.					
FS Date: 9/11/2013

Flapgate partially blocked by soil on WS toe.

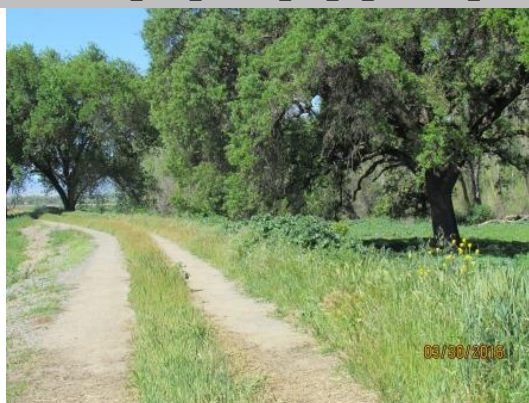
Photo 1 of 1 : SP\_2016\_RD2031\_307\_31\_20160412\_00086.jpg

View of the tall vegetation on the waterside levee slope.

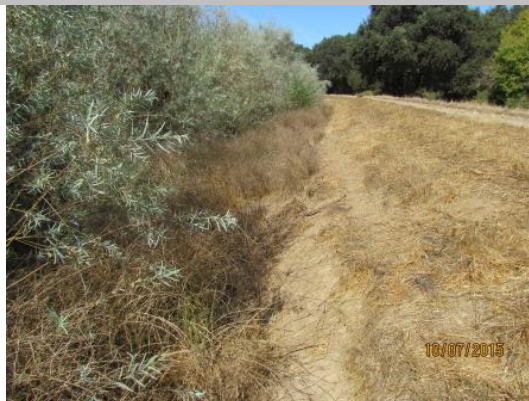
Photo 1 of 1 : SP\_2016\_RD2031\_307\_57\_20160229\_00031.jpg

View of the 18 inch vertical cut at the landside levee toe.

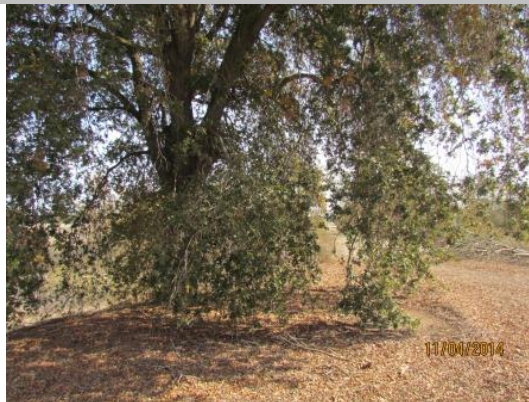
Photo 1 of 1 : SP\_2016\_RD2031\_308\_25\_20160229\_00008.jpg

View of the overgrown tree obstructing visibility and access of the landside levee slope.

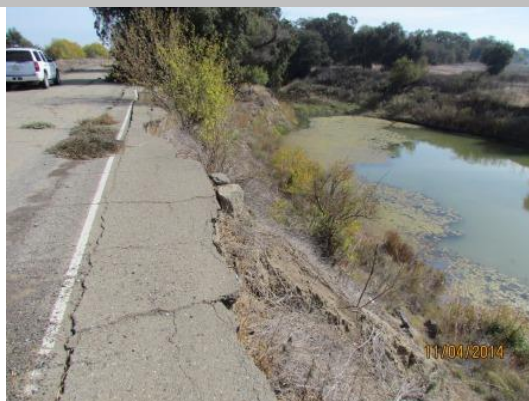
Photo 1 of 1 : SP\_2016\_RD2031\_308\_26\_20160229\_00009.jpg

View of the caving bank on the waterside facing upstream.

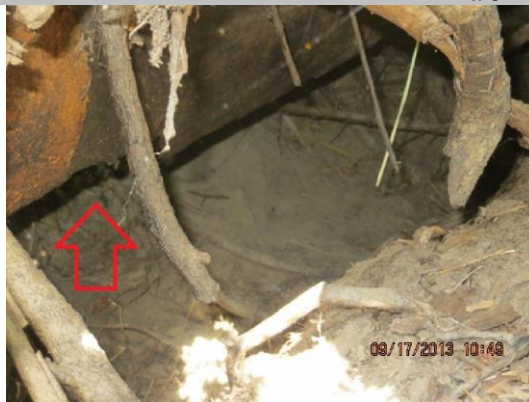
Photo 2 of 2 : UCIP\_SP\_2016\_20713\_34837.jpg

Flow line of pipe completely rusted through at LS toe.

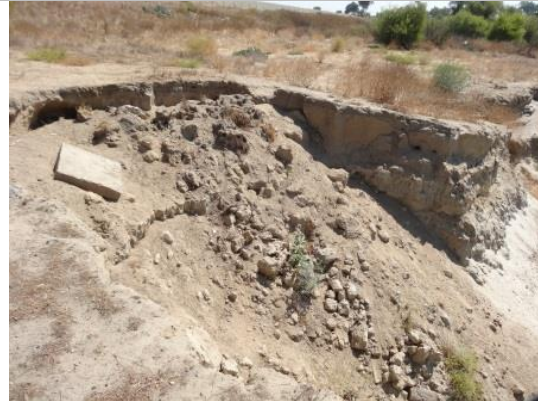
Photo 2 of 3 : SP\_2016\_RD2031\_308\_1\_20160229\_00002.jpg

Close view of the pocket erosion.

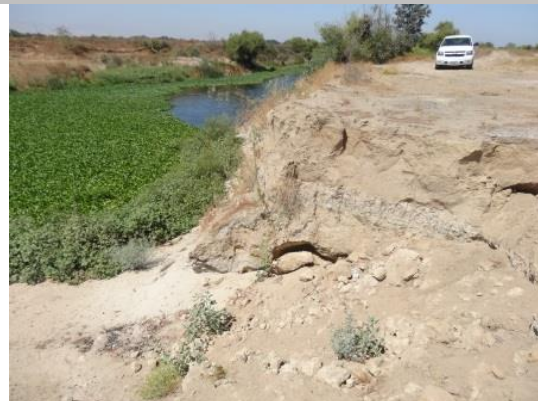
Photo 3 of 3 : SP\_2016\_RD2031\_308\_1\_20160229\_00003.jpg

Looking upstream. Note the pocket erosion.

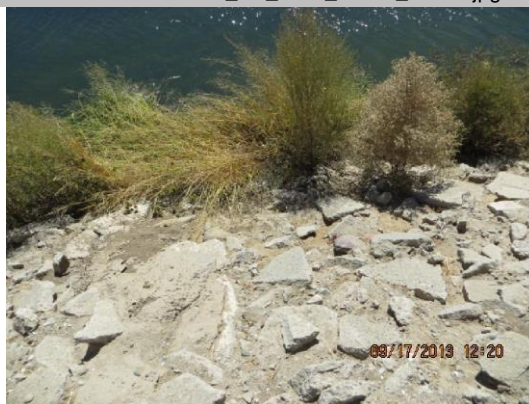
Photo 2 of 2 : UCIP\_SP\_2016\_22872\_39035.jpg

Concrete debris placed over pipe location on WS shoulder.
